Technical Bulletin

Date	Ref. No.	Model	BC			
22.03.02	TV01602	KV-29FX66E, KV-29FX66K, KV-29LS60B, KV-29LS60E, KV-29LS60K				
Subject						
East-West Distortion

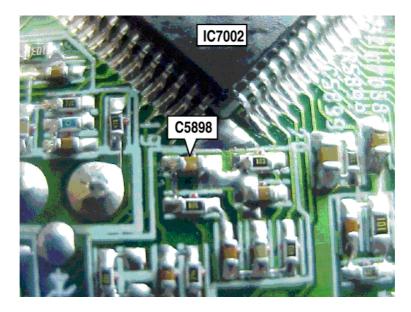
East-west distortion.

Q8803 on the D Board becomes defective after several hours of operation due to a breakdown of C5898 on the A Board.

Replace C5898 "Ceramic Chip 0.001µF 10% 50V" (1-162-964-11) and Q8803 "2SC5698-CA" (8-729-056-16).
